WETLAND DELINEATION REPORT

SOMERSET COUNTY EXPANSION PROJECT SOMERSET COUNTY, MARYLAND

GTA Project No: 31191824

Re: Wetland Delineation Report
Somerset County Expansion Project
Somerset County, Maryland

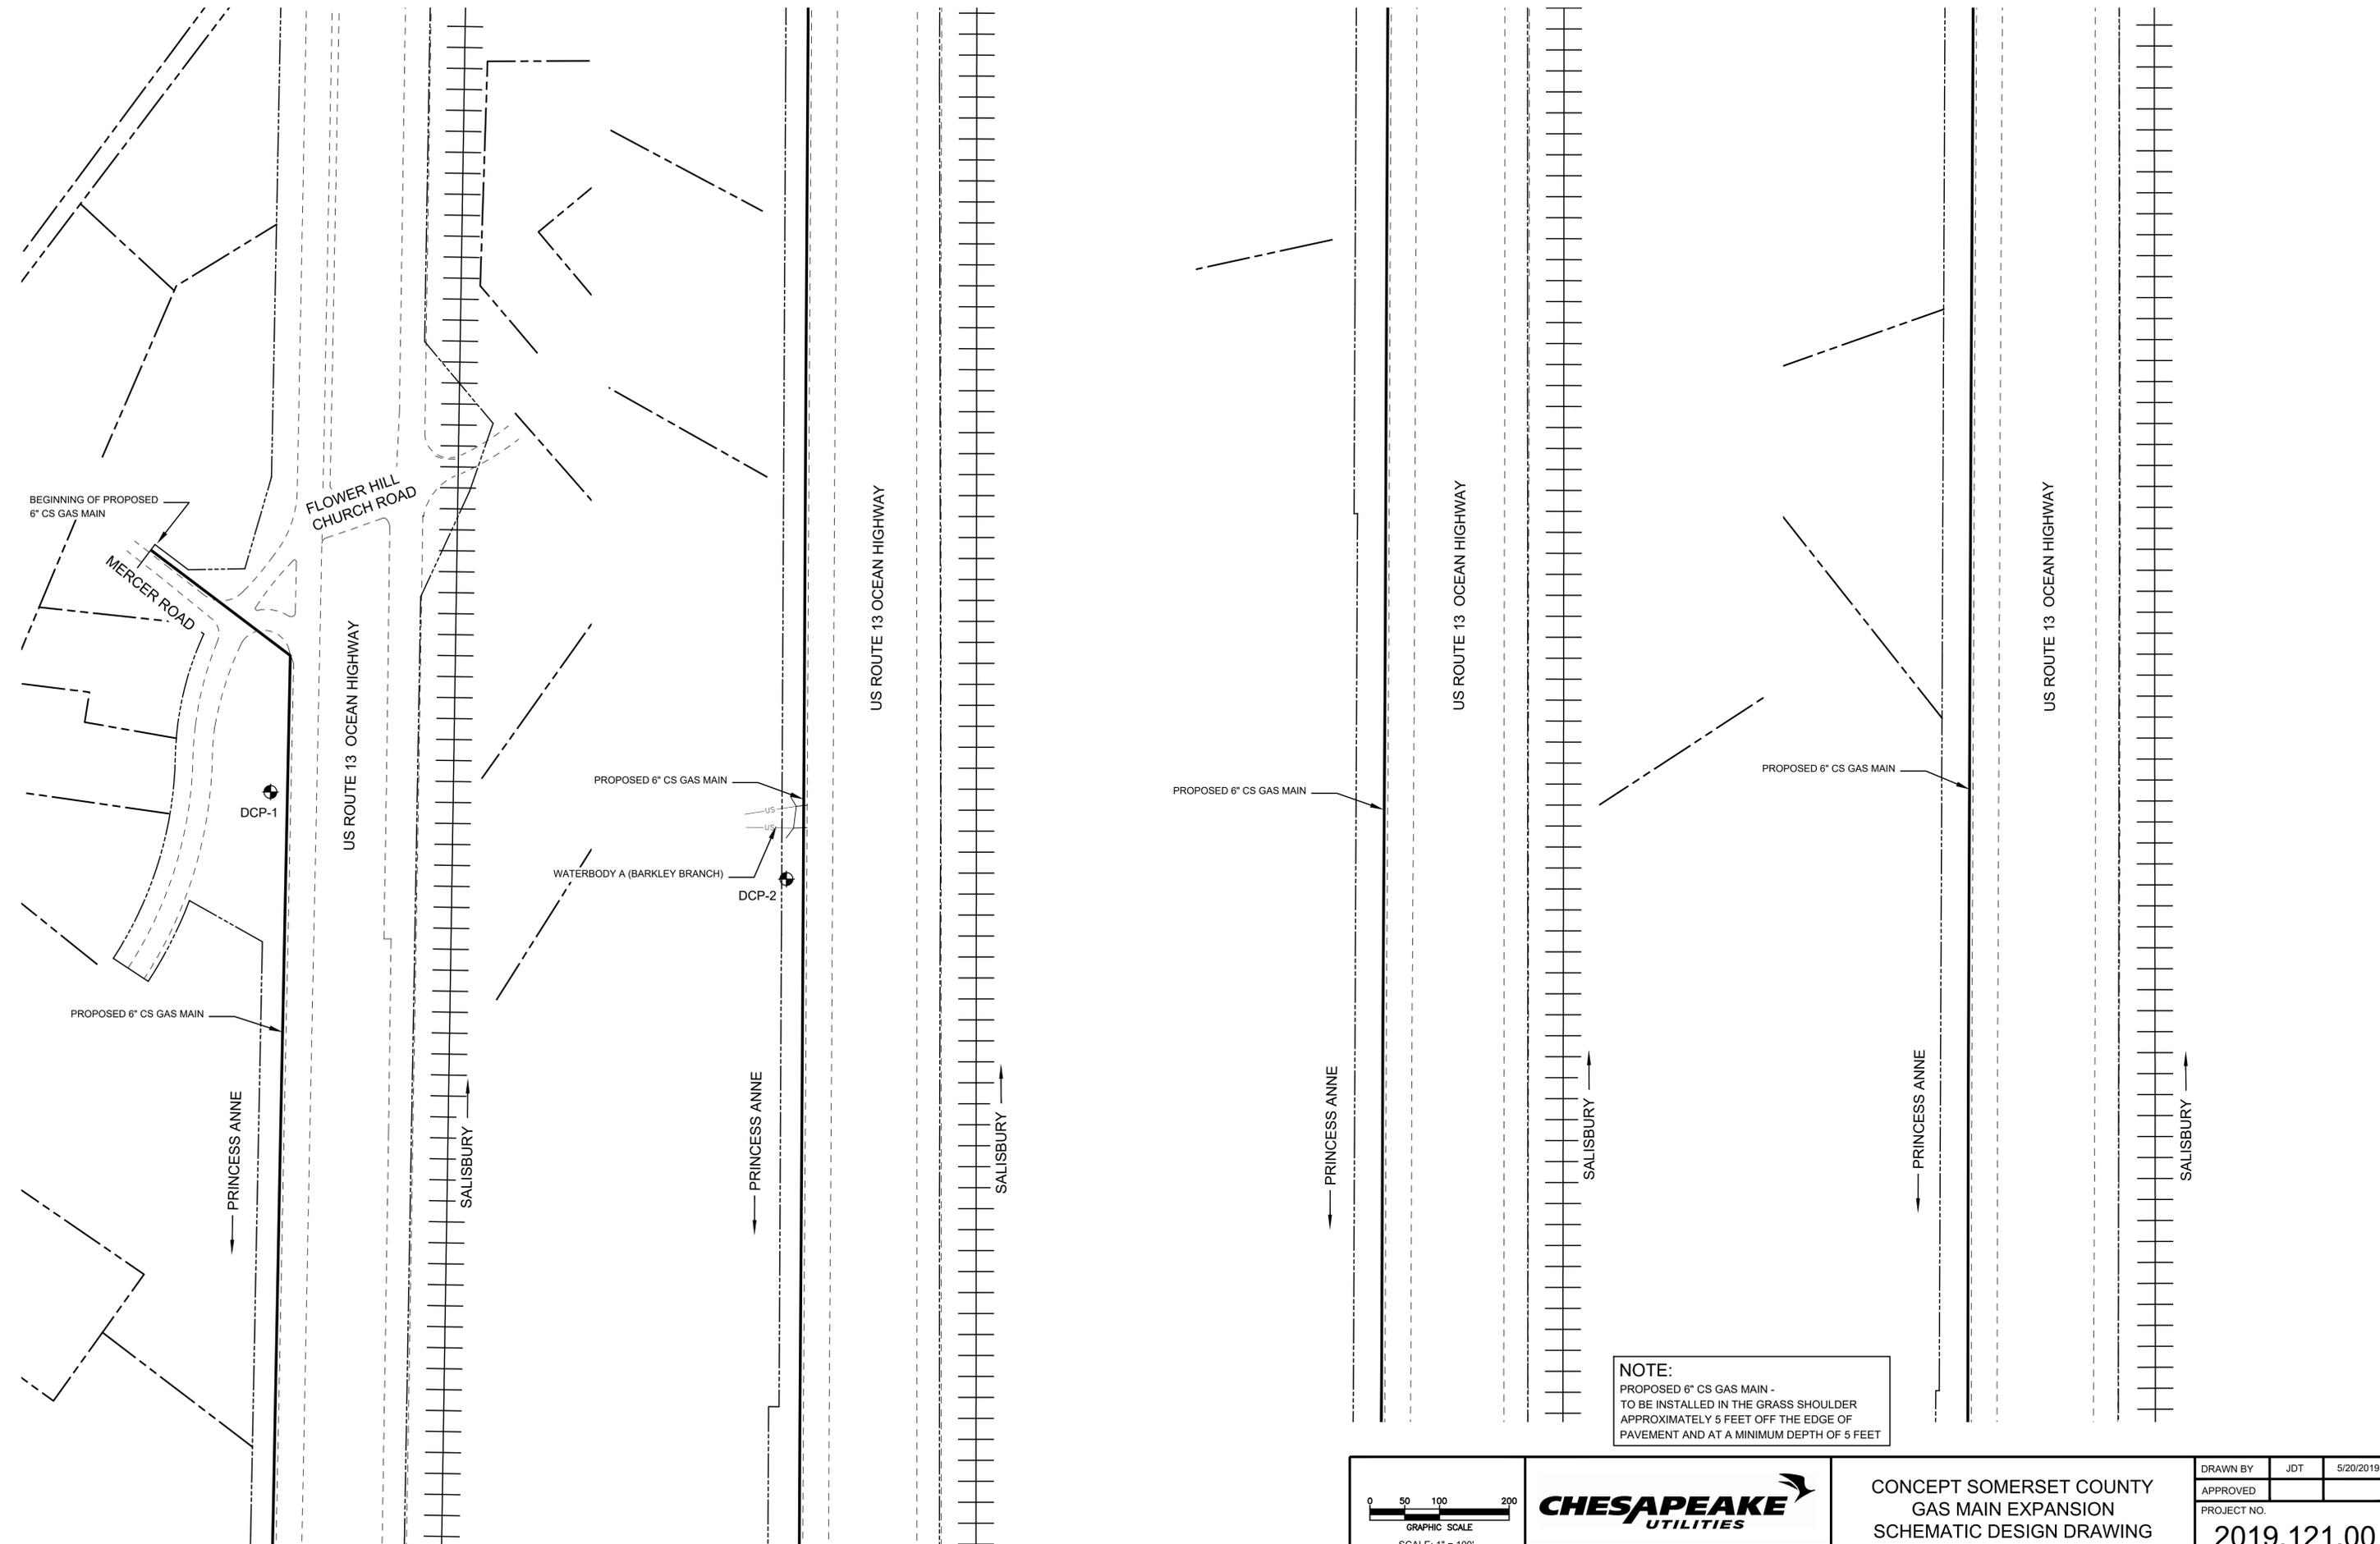
DRAWN BY	JDT	5/20/2019
APPROVED		
PROJECT NO.	2019.121.00	
	SHEET 2 OF 8

NOTE:
 PROPOSED 6" CS GAS MAIN -
 TO BE INSTALLED IN THE GRASS SHOULDER
 APPROXIMATELY 5 FEET OFF THE EDGE OF
 PAVEMENT AND AT A MINIMUM DEPTH OF 5 FEET

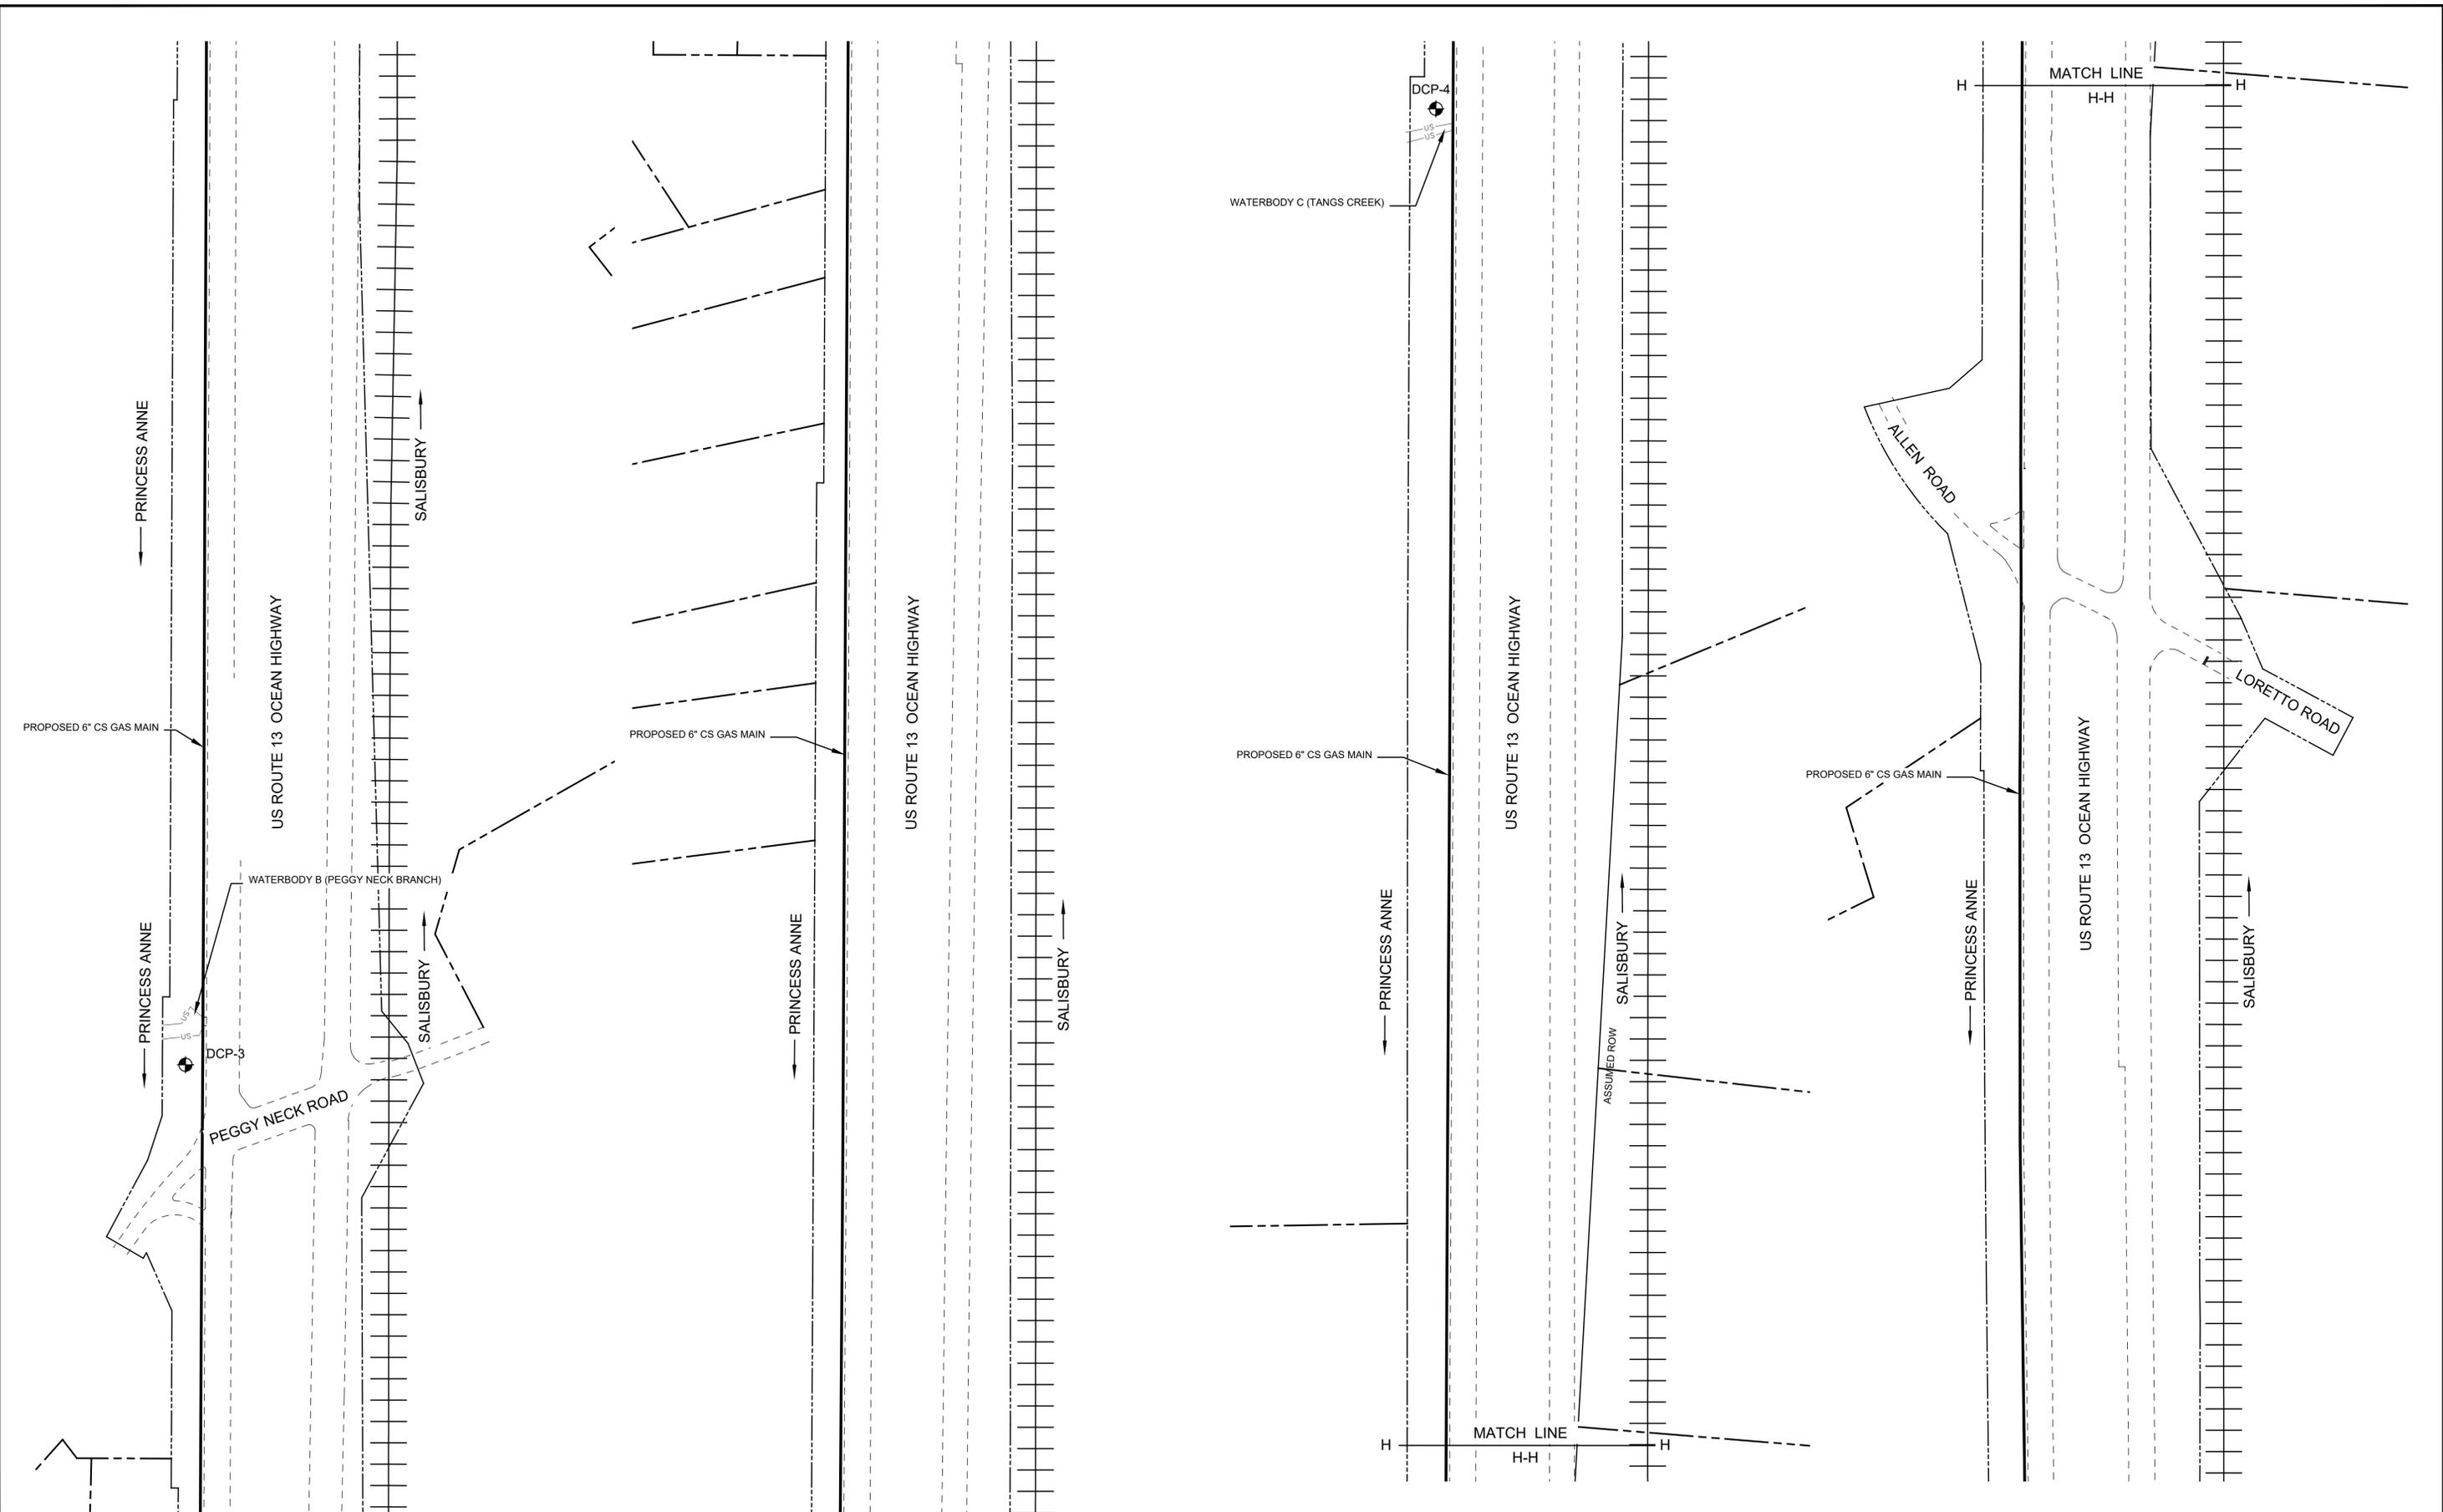
DRAWN BY	JDT	5/20/2019
APPROVED		
PROJECT NO.	2019.121.00	
	SHEET 3 OF 8

NOTE:
 PROPOSED 6" CS GAS MAIN -
 TO BE INSTALLED IN THE GRASS SHOULDER
 APPROXIMATELY 5 FEET OFF THE EDGE OF
 PAVEMENT AND AT A MINIMUM DEPTH OF 5 FEET

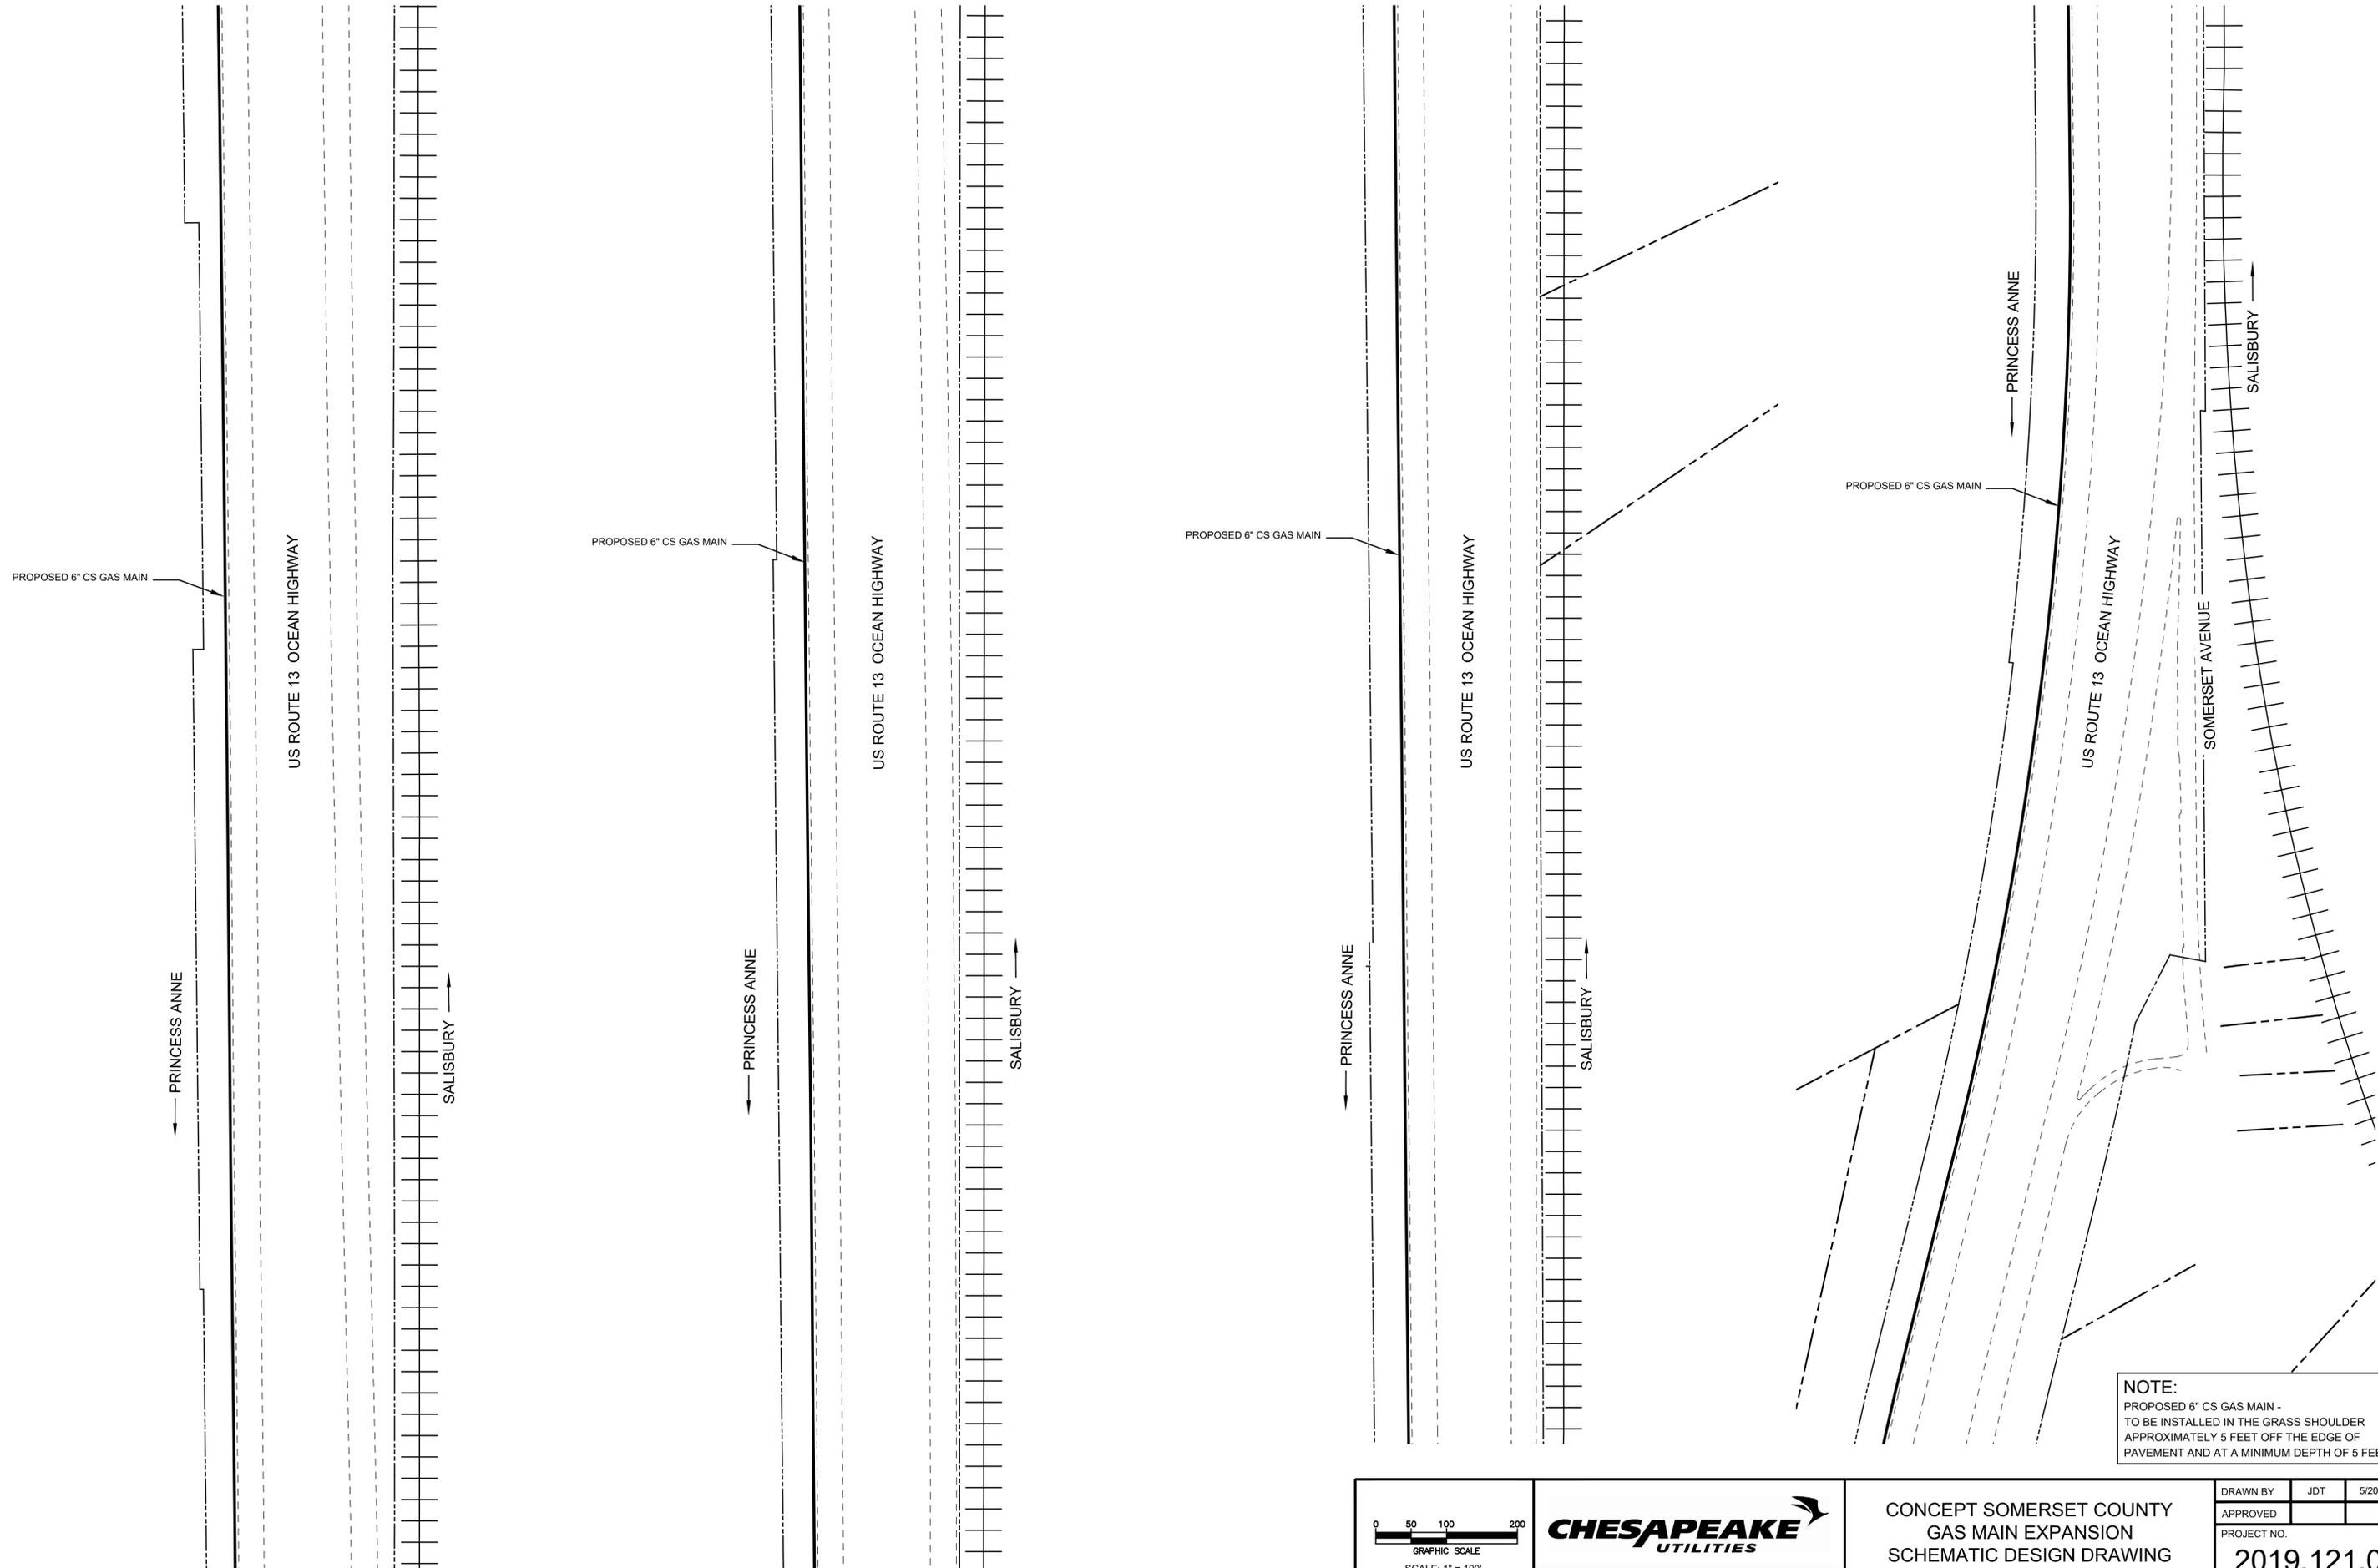
DRAWN BY	JDT	5/20/2019
APPROVED		
PROJECT NO.		
2019.121.00		
SHEET 4 OF 8

NOTE:
 PROPOSED 6" CS GAS MAIN -
 TO BE INSTALLED IN THE GRASS SHOULDER
 APPROXIMATELY 5 FEET OFF THE EDGE OF
 PAVEMENT AND AT A MINIMUM DEPTH OF 5 FEET

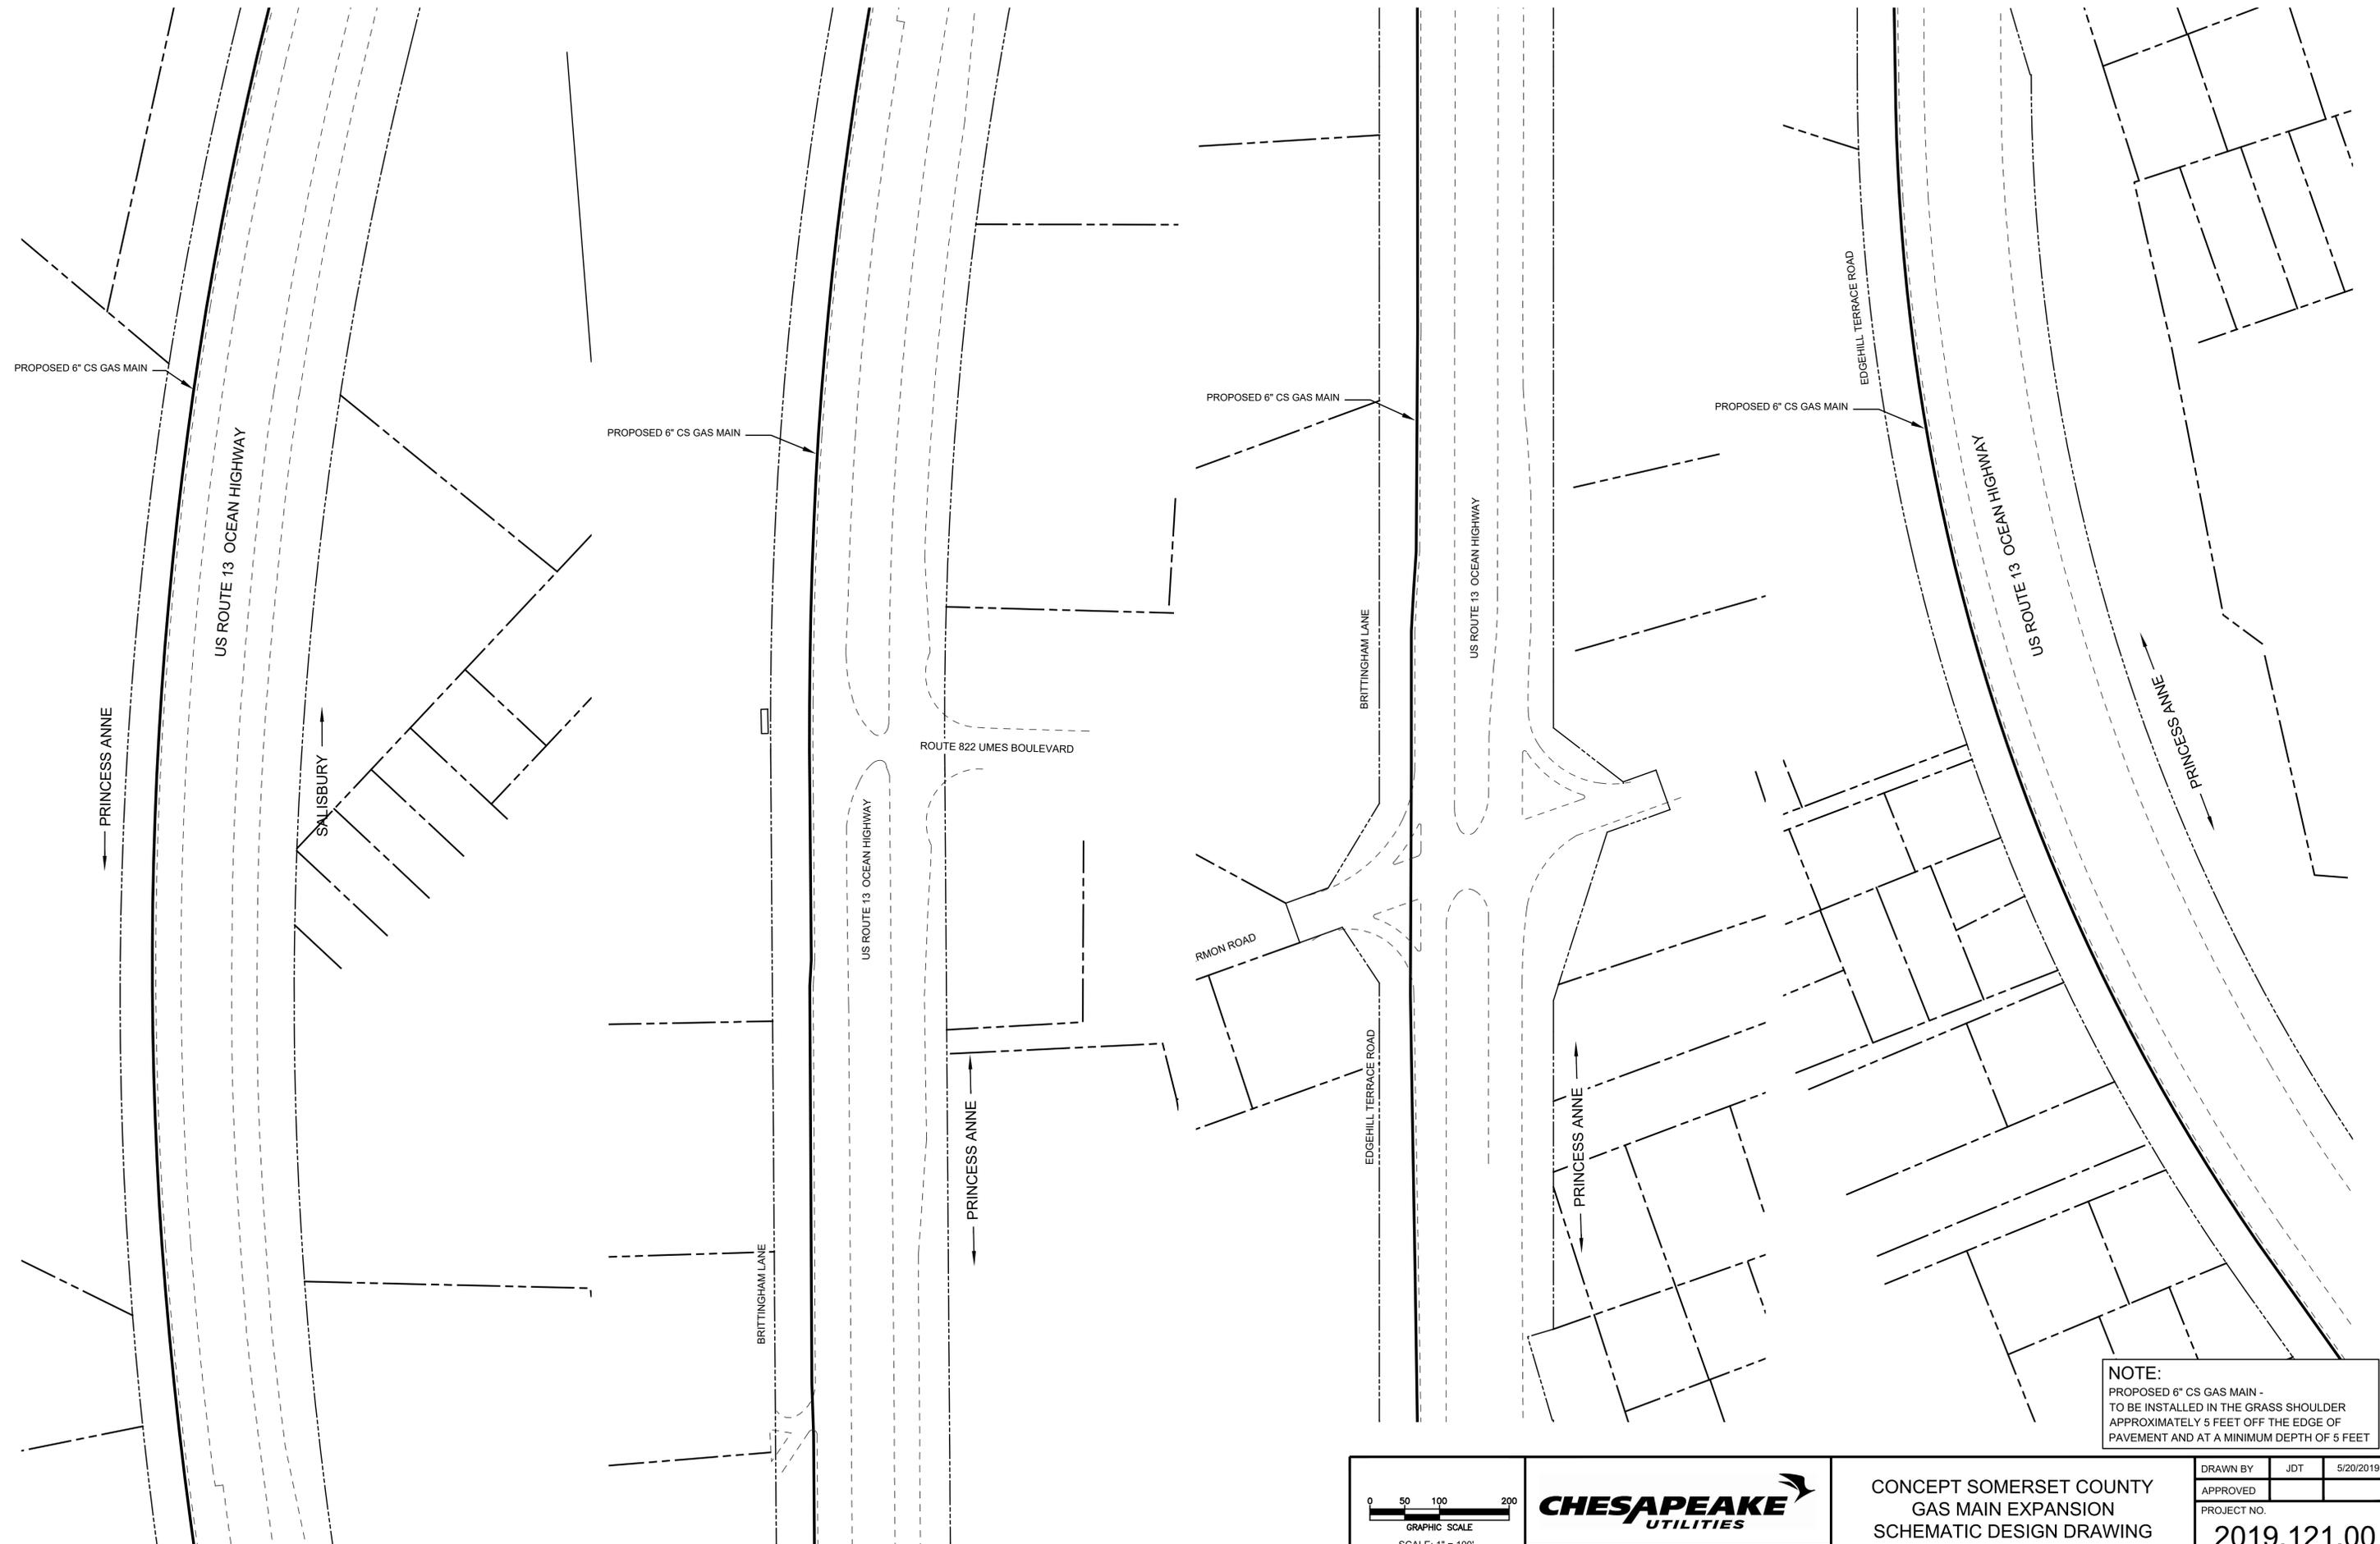
DRAWN BY	JDT	5/20/2019
APPROVED		
PROJECT NO.	2019.121.00	
	SHEET 5 OF 8

NOTE:
 PROPOSED 6" CS GAS MAIN -
 TO BE INSTALLED IN THE GRASS SHOULDER
 APPROXIMATELY 5 FEET OFF THE EDGE OF
 PAVEMENT AND AT A MINIMUM DEPTH OF 5 FEET

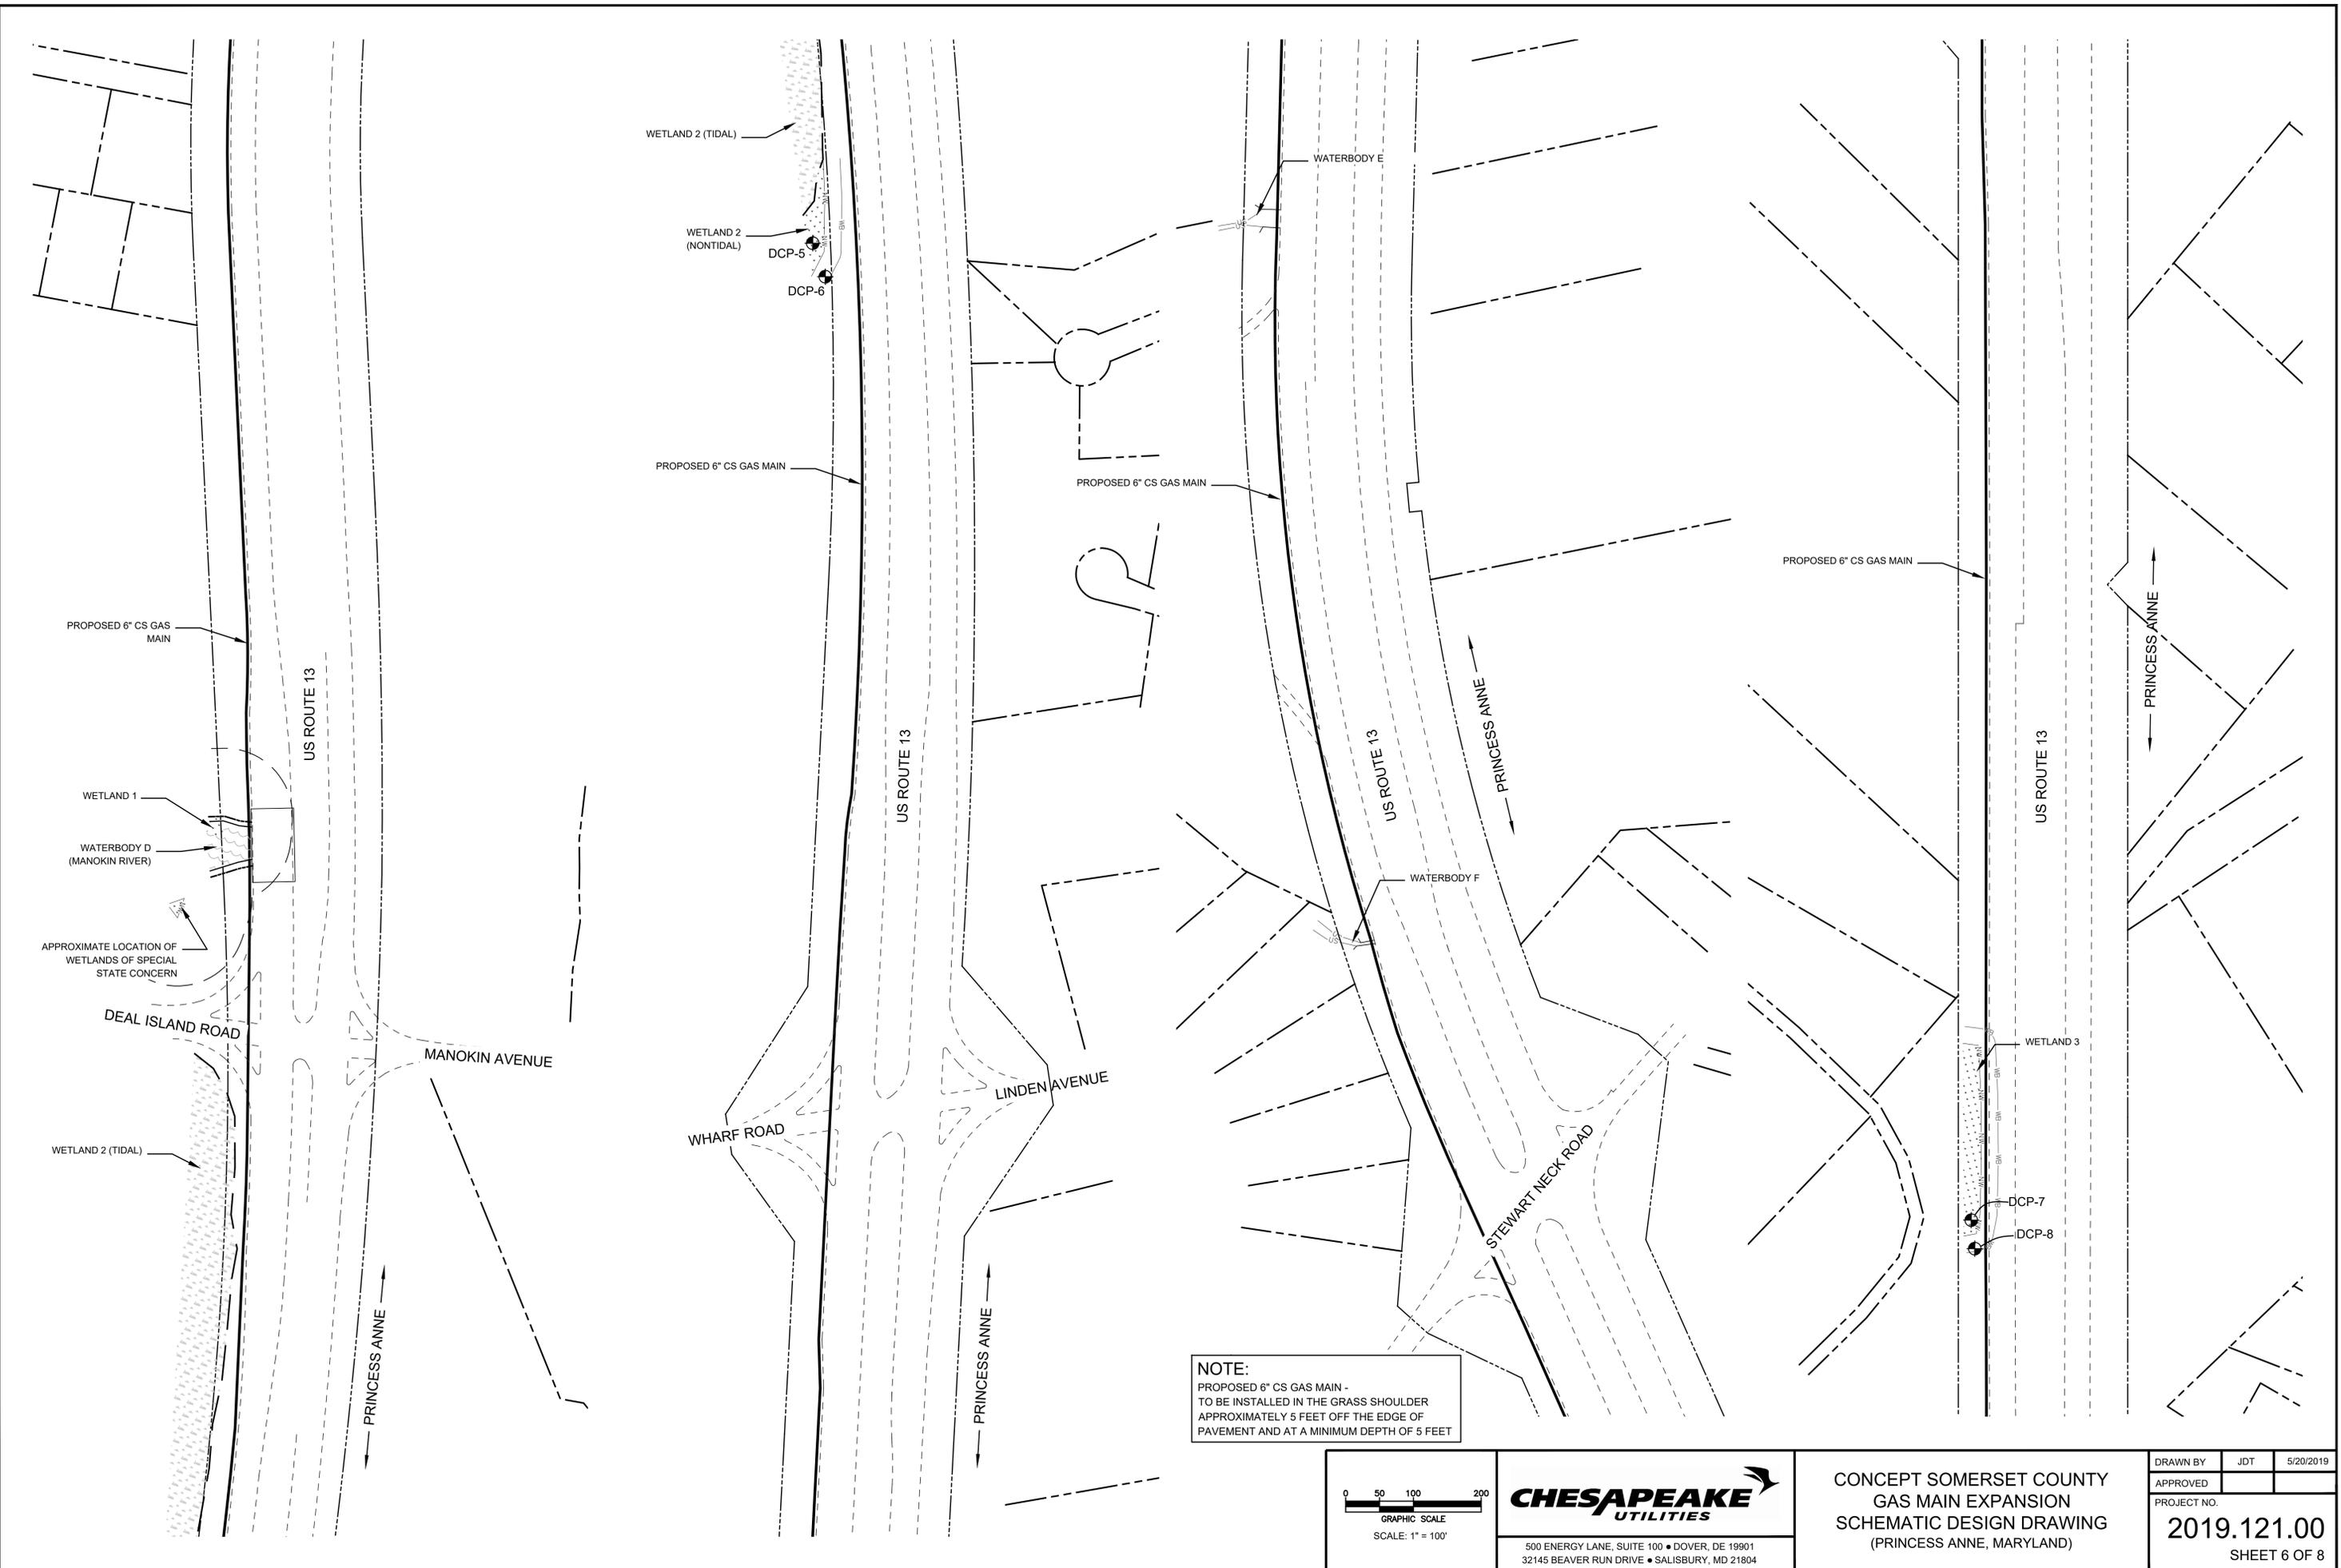
DRAWN BY	JDT	5/20/2019
APPROVED		
PROJECT NO.	2019.121.00	
	SHEET 6 OF 8

NOTE:
 PROPOSED 6" CS GAS MAIN -
 TO BE INSTALLED IN THE GRASS SHOULDER
 APPROXIMATELY 5 FEET OFF THE EDGE OF
 PAVEMENT AND AT A MINIMUM DEPTH OF 5 FEET

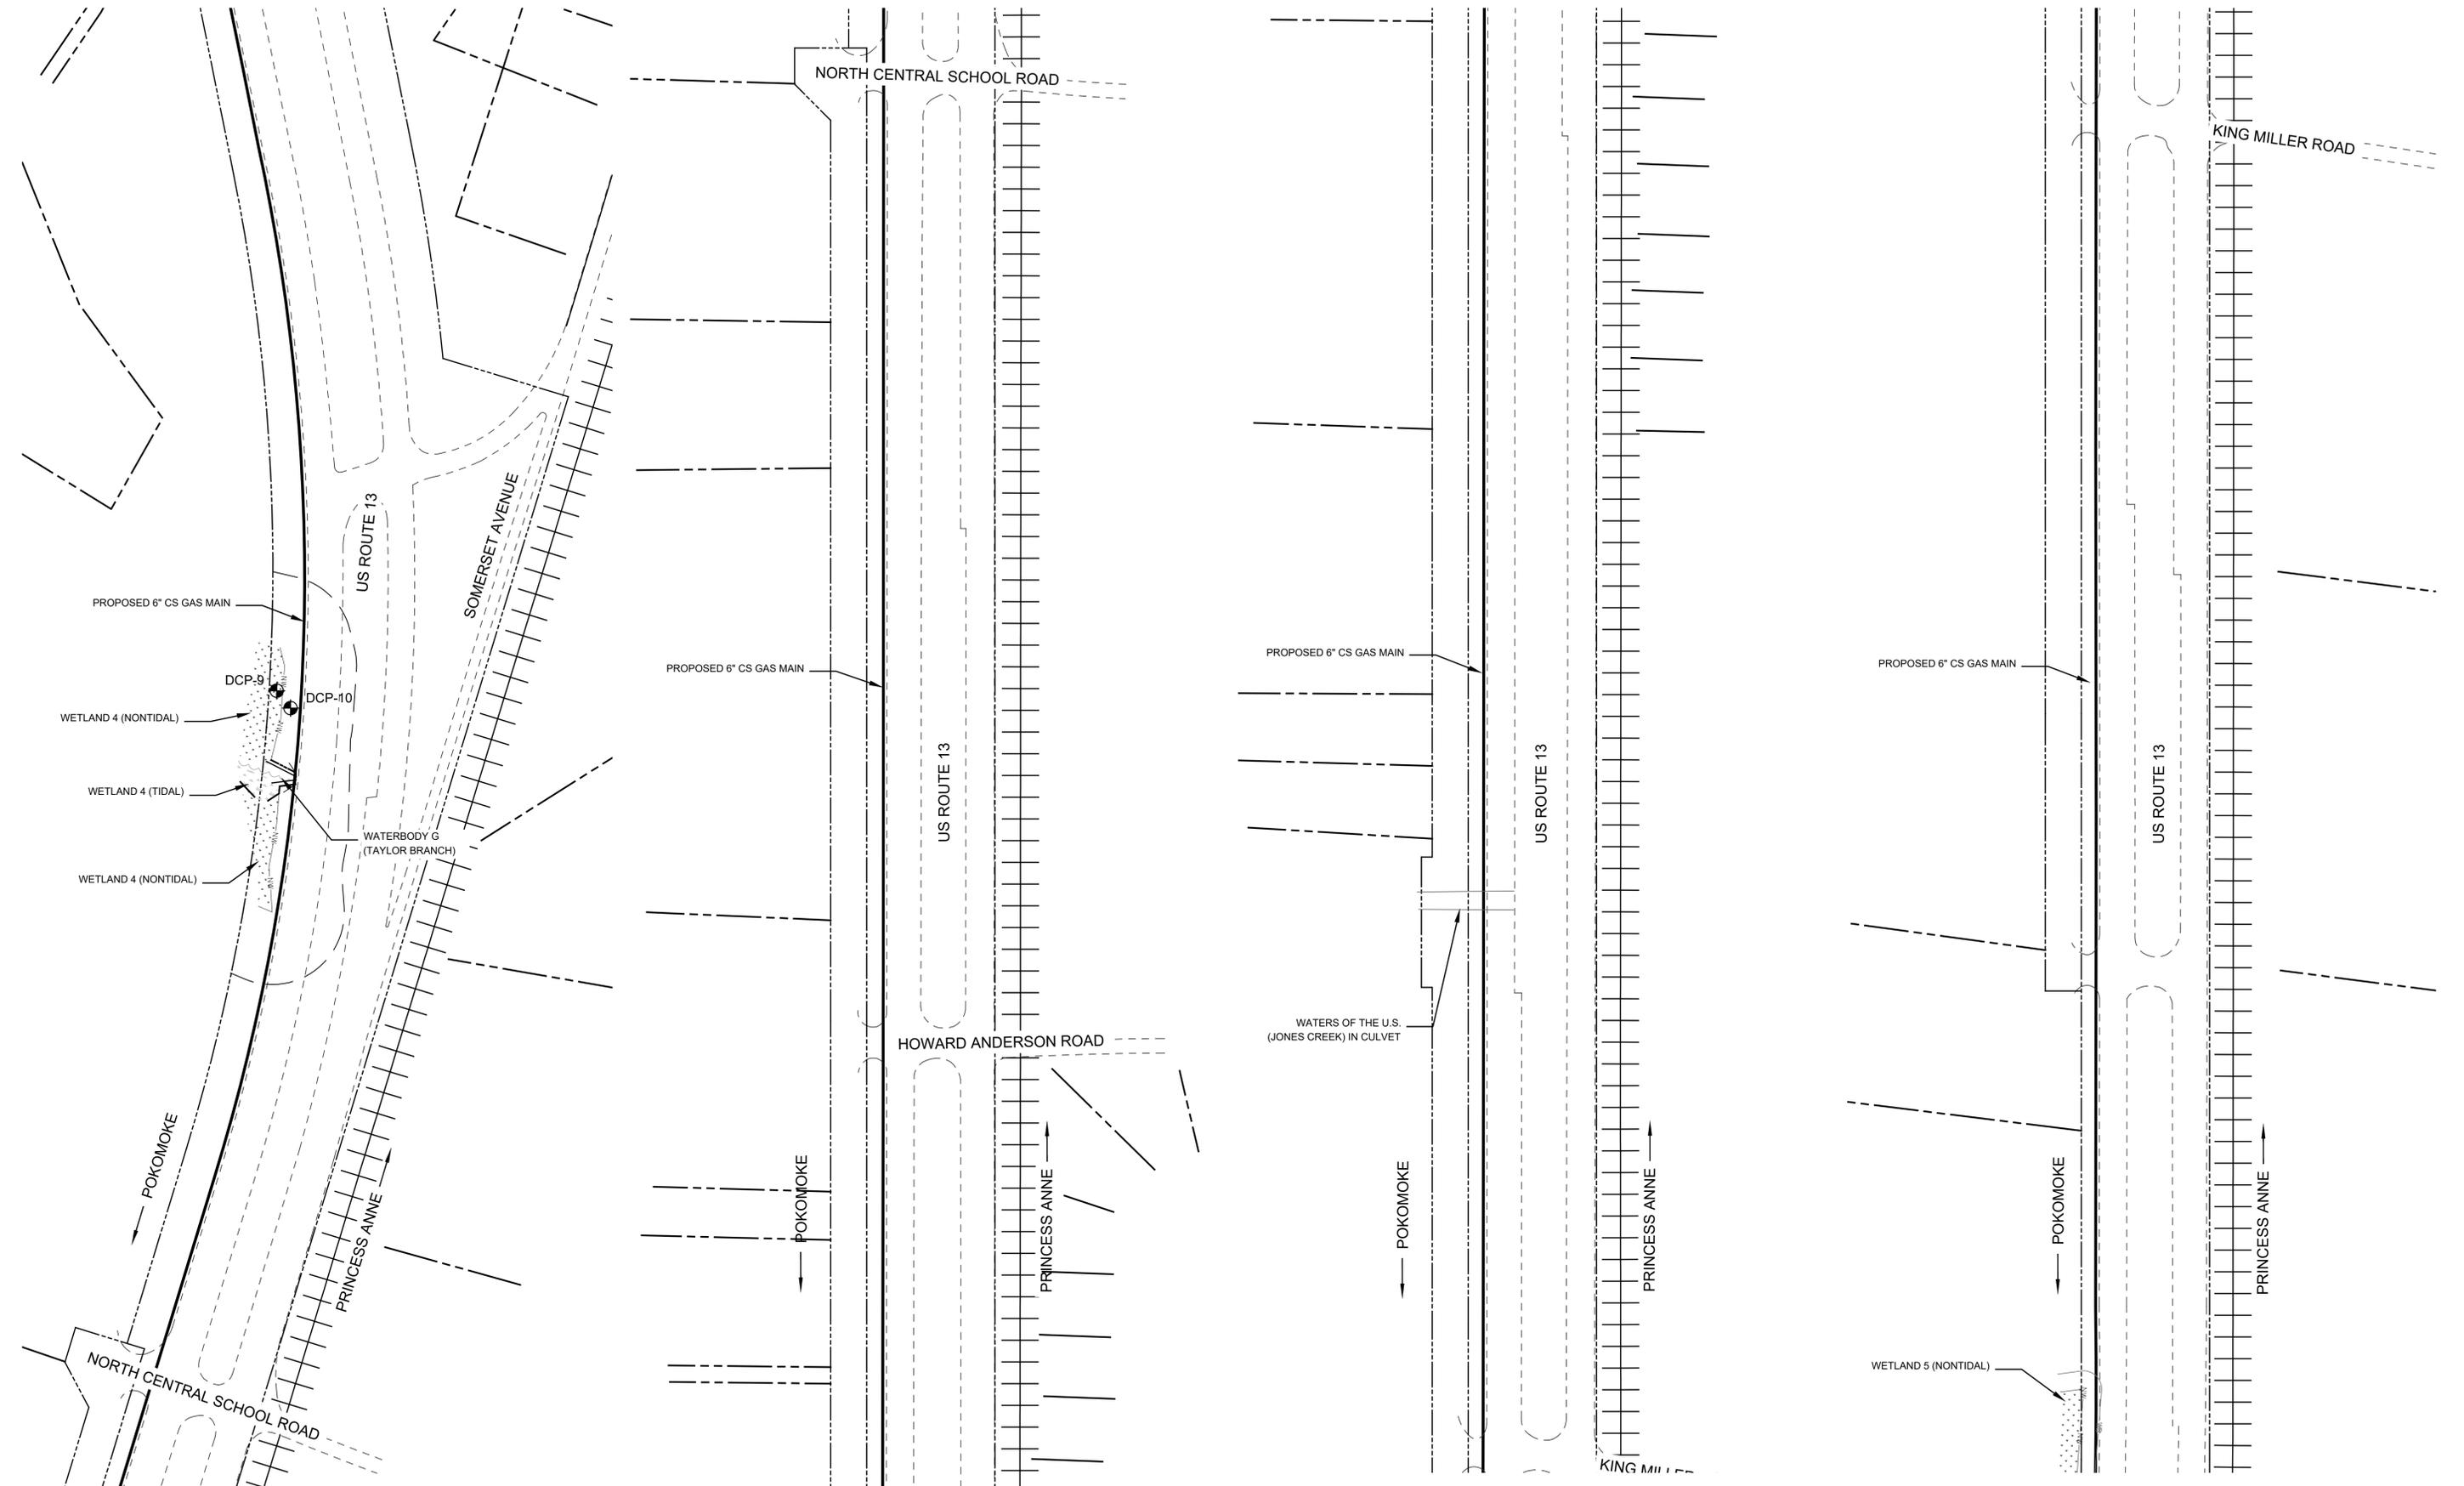
DRAWN BY	JDT	5/20/2019
APPROVED		
PROJECT NO.	2019.121.00	
	SHEET 7 OF 8

NOTE:
 PROPOSED 6" CS GAS MAIN -
 TO BE INSTALLED IN THE GRASS SHOULDER
 APPROXIMATELY 5 FEET OFF THE EDGE OF
 PAVEMENT AND AT A MINIMUM DEPTH OF 5 FEET
